SWAFFHAM CONSERVATION AREA APPRAISAL ADOPTED 25TH APRIL 2022

SWAFFHAM CONSERVATION AREA APPRAISAL CONTENTS

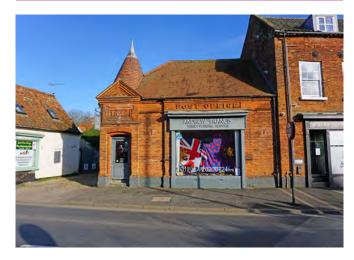
No.17 Market Place

Reasons for Identification

- Landmark status as a focal point on the route into Swaffham from Lynn Street;
- Historic interest as the former post office;
- Aesthetic interest in the conical turret roof and elegant moulded brickwork, including date stone and post office sign; and
- Consistency of materiality with the Conservation Area.

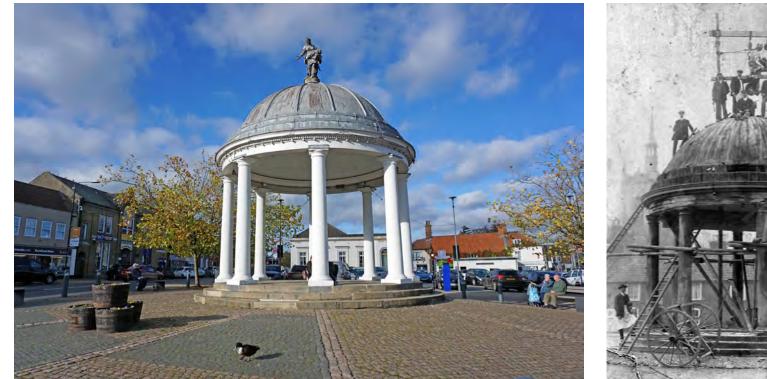
Another relative of the Nelsons, George Walpole 3rd Earl of Orford, paid for the domed market cross (Butter Cross) in the Market Place at Swaffham earlier in 1783.²² It is topped with the Roman goddess of the harvest, Ceres, which may have been from the Walpole collection at Houghton Hall (Walpole was Lord Nelson's second cousin-once-removed). The Butter Cross has undergone many repairs throughout the twentieth and twenty-first centuries.

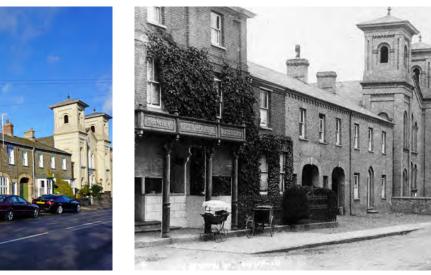
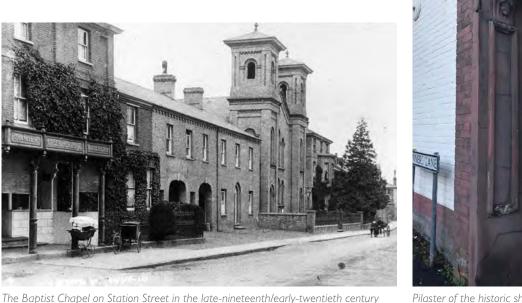
Baptist Chapel

A comparison of a photograph from the latenineteenth/early-twentieth century and the scene today shows that this part of the street is relatively unchanged. The terraced houses, with same dentiled cornice as that of the Chapel, may have been part of the expansion in the 1880s. The end property remains in commercial use to this day, though the ornate timber canopy with its columns and sign advertising Green & Kerridge Family Butchers had been lost and replaced, although evidence of the former shopfront remains in pilasters and corbels either side of the modern shopfront.

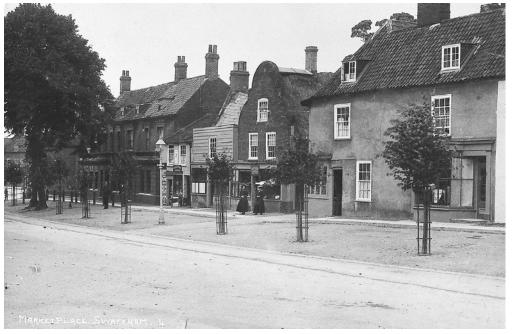
East side of the Market Place, showing buildings before demolition and replacement with the current lceland (to the right) and Nos.69-73 (to the left) (courtesy of Swaffham Heritage)

The south side of Church Walk was demolished in the 1960s to make way for a Woolworths, now an Iceland, and was built in a style not in-keeping with the local area. It did, however, make the lane wider. The Dutch gable-ended shop on the north side of the lane has been retained, though much of its rear has been altered, in particular it no longer has a thatched roof. It is surprising that this building kept its thatch for so long despite the history of fires in the town. The shops to its north have been demolished to make way for a simpler one-storey structure, then the two storey building with rusticated ground floor and dormer windows beyond that has also been replaced with a modern building.

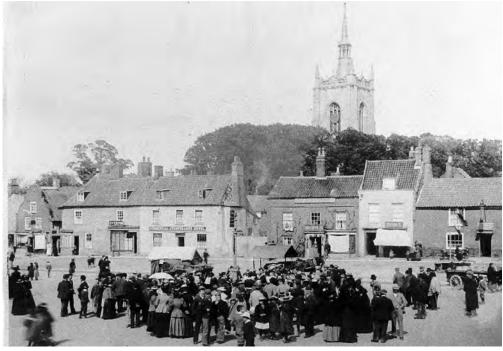
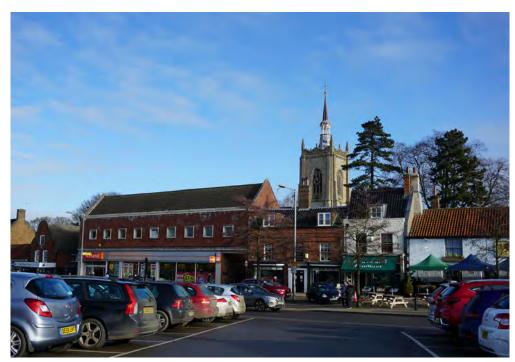
The east side of the Market Place (courtesy of Swaffham Heritage)

In these views the floorscape is completely different due to the tarmac, cars, and pavements. The building with the Dutch gable is still in existence today. The two buildings to the right of Church Walk (one shop noted as Overton's and the other as the Commercial & Temperance Hotel) are replaced with Iceland in the modern photograph. To its right, the two shops and the Red Lion appear relatively unchanged although No.83 now has a shop window inserted to the left of its front door.

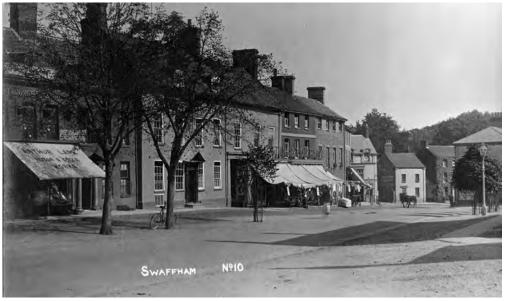
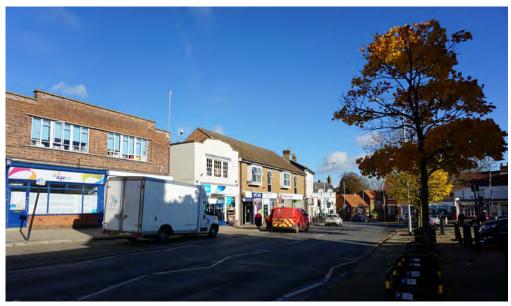
North side of the Market Place (courtesy of Swaffham Heritage)

Much of this row has been replaced by twentieth century shops, though Nos.53-59 Market Place remain reasonably the same (No.53 visible, painted white at the right hand end of the row), together with the view of the George Hotel. Much of the space in-between (Nos.43-51) has been replaced with newer nineteenth and twentieth century buildings. Arthur Lane's shop is numbered 10 in the photograph, which does not correspond to contemporary numbering of that side of the Market Place.

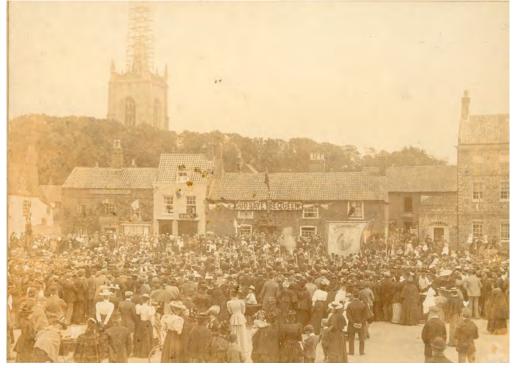
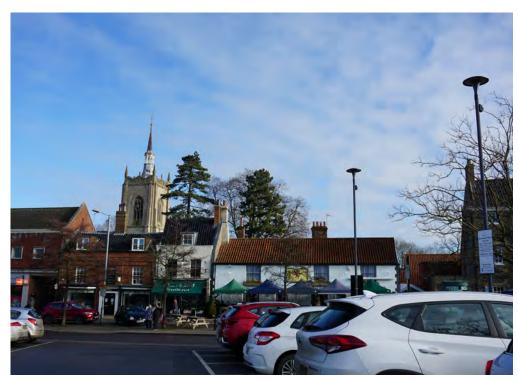
1897 Diamond Jubilee celebrations in the Market Place (courtesy of Swaffham Heritage)

It is interesting to note in this historic photograph the scaffolding on the lantern and spire of the church which, according to Pevnser, was reworked in the same year as Queen Victoria's Diamond Jubilee. The line of four buildings (Nos.81-87 (The Red Lion), plus, on the south side of Pit Land, No.89, Montpellier House) are preserved relatively as they were. Once again, on the left of the 1897 image, is the building which made way for Woolworths (now Iceland) in the 1960s.

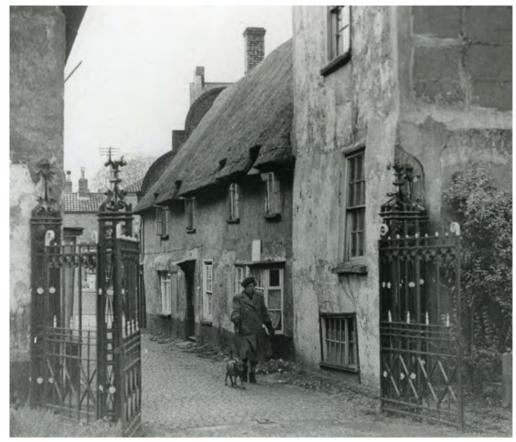
Church Walk looking west, with thatched building on the right (courtesy of Swaffham Heritage)

Church Walk which connects the Market Place with the churchyard has altered significantly. Owing to the demolition of the building on the south side of the lane, it is now broader, as can be seen by the small sections of fences added either side of the gates and the cobble stones only taking up part of the pathway. The modern bollards effectively mark the original width of the lane. The thatched building on the right in the historic photograph is no longer thatched but tiled and the walls substantially rebuilt. The easternmost building has also been rebuilt.

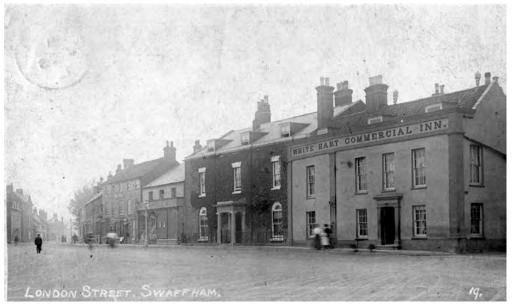
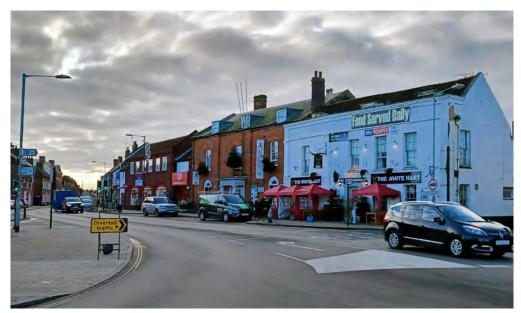
The southern end of the Market Place and London Street (courtesy of Swaffham Heritage)

Apart from the signs and banners, the White Hart is only mildly altered, although its comer pilaster is missing a capital, the parapet no longer has the inn's name painted on and the front door has been moved one bay to the left. The central chimney stack has also been lost. The Museum building (originally Oulton House built in the late-eighteenth century then used as the Town Hall from the 1955) remains much the same. The main change between these photos is the two buildings on the left, one of which being a Cooperative with an impressive, glazed shopfront, which were demolished to make way for a large twentieth century structure now QD.

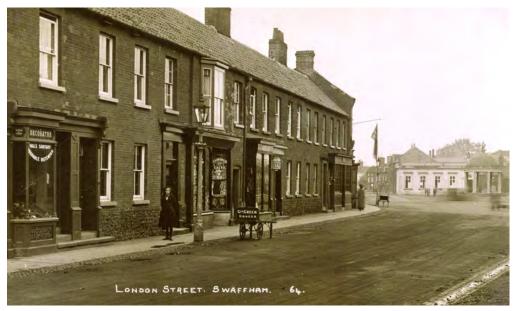
London Street looking north towards the Market Place (courtesy of Swaffham Heritage)

The long range of buildings on the left hand side of the photographs has survived with the rhythmic first floor windows remaining. The rendering of some individual buildings and the insertion of shopfronts has eroded the consistency of appearance. However, some of the good quality historic shopfronts and doorcases, as well as the distinctive first floor bay window have survived. The view northwards to the Butter Cross and Assembly Rooms remains but with the addition of the modern roadway and traffic.

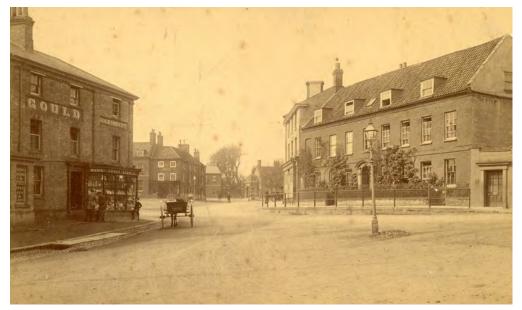
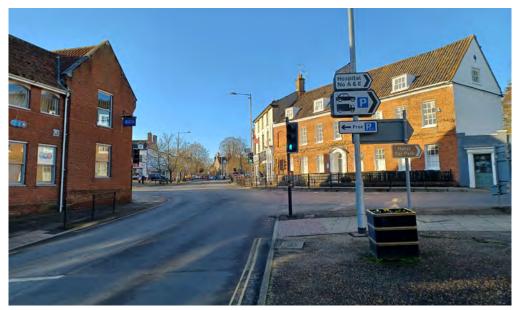
No.59 Market Place, on the right hand side of the image, has survived with little change except that the decorative metal railings to the front have been replaced with a timber picket fence. On the left, however, Gould's has been replaced with a modern bank (in 2021 a TSB). Gould's was a prominent business on the east side of the Market Place in the late-nineteenth and through the twentieth century until the 1960s when the building was demolished and replaced with the one seen here. The roadway is again formalised and with multiple items of street furniture. Beyond the trees in the background the historic buildings seen in the older photograph have also been lost and replaced with the building which is now partly vacant and partly a Nationwide. The Bagge Memorial is visible in the distance in the older photograph, which has since been removed.

Junction of Market Place, Mangate Street and Station Street looking west (courtesy of Swaffham Heritage)

A similar view in 2021

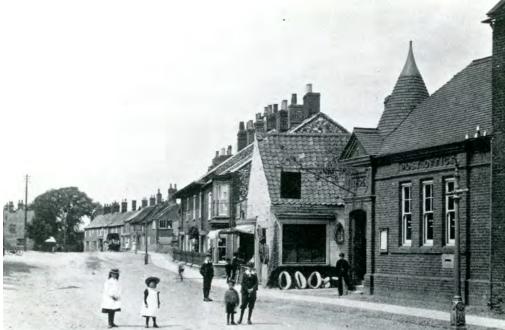
Largely the terraced rows of houses on Lynn Street have remained reasonably unchanged, particularly those houses that are listed nearer to the town centre. However, several have had uPVC windows added or their brick frontages rendered. No.2, now a dog grooming business, appears to have been a saddlery shop with the bay window facing the street used as a shop window with awning above. The old post office was still in its original use in the earlier photograph, with a postman standing at the door. It has since been altered to accommodate a large shopfront window and has lost its iron wall mounted sign and bracket but has retained its other original features.

Lynn Street looking north (courtesy of Swaffham Heritage)

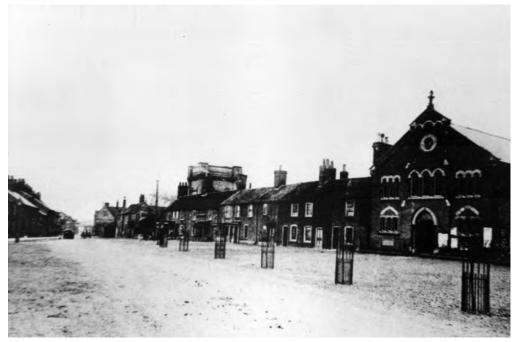
Notably in this historic photograph, looking southwards along the west side of Lynn Street, are two prominent buildings which have since been demolished: the large tower of the old gas works, now the site of the present-day ASDA supermarket, and the Methodist chapel, the site of a garage. The row of cottages survives between but with several alterations, such as uPVC windows and rendering of brickwork. The saplings seen newly planted in c.1900 have now matured into sizeable trees which line the west side of the street. The space between the trees and buildings has now become parking.

Lynn Street looking south, with water tower and Methodist Chapel visible (now demolished) (courtesy of Swaffham Heritage)

A similar view in 2021

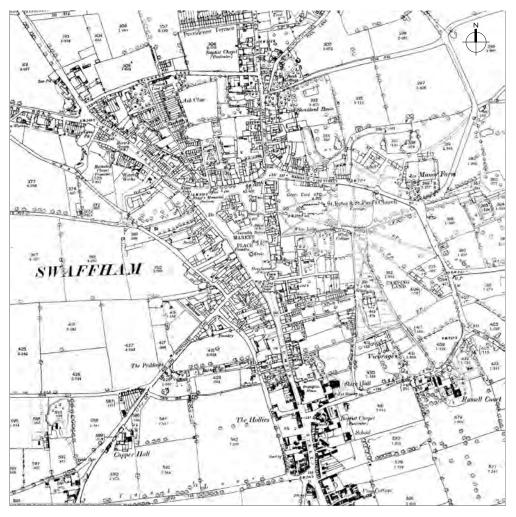
1884 Ordnance Survey map 1:2,500. Ordnance Survey (c) Crown Copyright 2021. All rights reserved. Licence number 100020449

4.3.5 The Twentieth and Twenty-First Centuries Comparing the OS maps from 1884, 1905 and 1928 there is reasonably little change to the overall layout and spread of development in Swaffham. The number of buildings close to the centre of the town during this period remains much the same. There are some slight changes between 1884 and 1928, with a few new houses on the outskirts, such as the first few pairs of semi-detached houses built on Pedlar's Grove to the north and council houses on The Crescent, constructed off White Cross Road in 1920 to the south-west. By 1970, the post war expansion of the town is evident. New houses have been built on new and existing roads on the outskirts of the town, creating a much larger settlement than had existed historically.

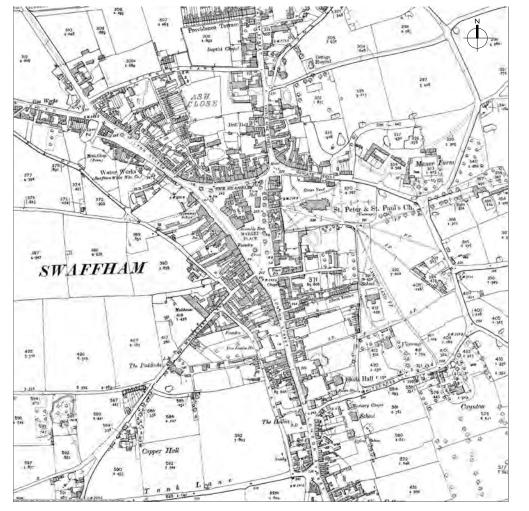
1905 Ordnance Survey map 1:2,500 . Ordnance Survey (c) Crown Copyright 2021. All rights reserved. Licence number 100020449

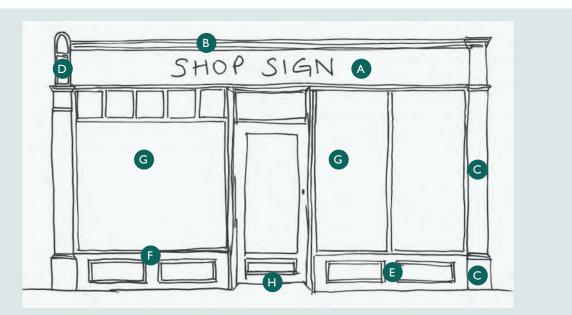
- Fascia: The space above the window used to promote the name of the shop, which is often the predominant element of the shopfront.
- B Cornice: A moulded element across the top of a fascia designed to throw water away from the building.
- C Pilaster and Plinth: Pilasters (half-columns) frame the shopfront at either edge and provide visual support to the fascia and upper floors. Sometimes these were ornamented. The plinth is a wider element at the base of the pilaster.

- Console/Corbel: These sit on top of the pilasters and protect the end of the fascia.
- E Stall Riser: The solid base to the window, helps to protect against damp and damage to the glazing. It also forms a solid base to the shopfront, providing it with balanced proportions.
- Sill: The moulded element sitting on top of the stall riser, designed to throw water away from the building.

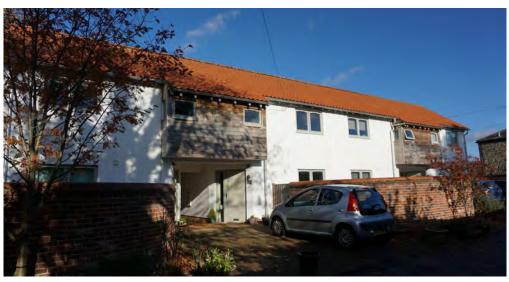
Spaces in between the historic buildings have often been filled in with twentieth century houses or bungalows. Most are in red brick and have a few simple vernacular details like dentiled cornices, though their designs generally do not have the same richness as the historic buildings. There are a few better quality modern buildings. For example, there is a relatively new terrace of houses on The Pightle which has a similar scale to other terraced houses in the Conservation Area and utilises a clay pantile roof. However, it is in a modern style and has rendered walls and timber cladding to bay windows which, though not so common in the area, have been used well. Another good quality modern house is also on the Pightle, though this time in a more traditional Neo-Georgian style, in red brick with a slate roof and sash windows. The quality of materials makes a positive contribution to the area.

Good quality houses in a contemporary style on The Pightle

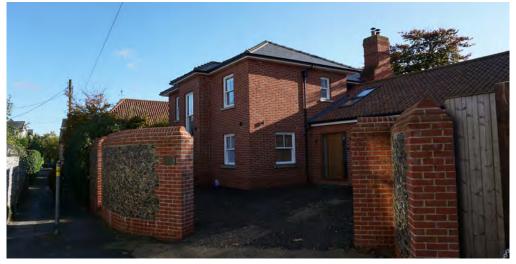
Good quality house in a traditional style on The Pightle

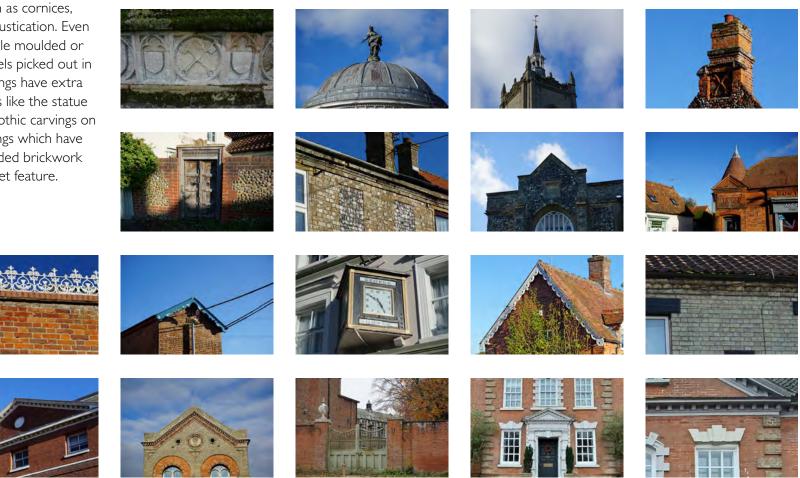
Architectural Details Palette

Grander buildings and those in the Georgian style have typical details from that style, such as cornices, string courses, pediments, quoins and rustication. Even some of the smaller cottages have simple moulded or dentilled cornices or blind window panels picked out in contrasting materials. Sometimes buildings have extra flourishes, either on key public buildings like the statue of Ceres on the Butter Cross or the Gothic carvings on the Church, or on more modest buildings which have decoration such as barge boards, moulded brickwork or, in one case, a decorative iron parapet feature.

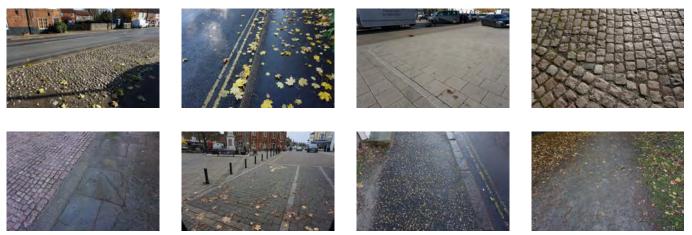
Examples of flint cobbles, granite setts, tarmac, paving slabs and gravel

Roads and pavements outside of the Market Place are more utilitarian, in tarmac, which is sometimes patchy, though there are good granite kerb stones in many places. There are some flint cobbled areas next to pavements on Lynn Road, though these are in need of some repair. Some of the Churchyard paths and those in Campingland and across the Antinghams are gravel or grass tracks.

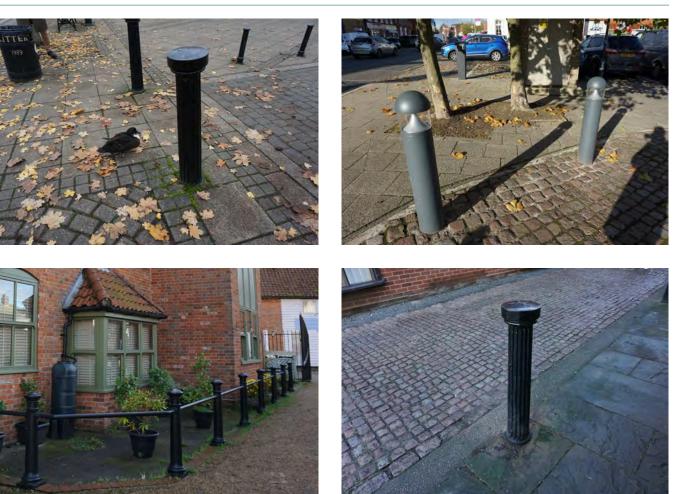
Bollards are a feature of the Market Place, demarcating spaces. Around the Butter Cross, these are from a more modern landscaping scheme and are pale metal with integrated lights. Victorian style bollards of black iron, sometimes fluted columns or plain with two bulges, are used throughout the rest of the Market Place, which were installed in a 1980s scheme of works. These mark specific parking bays, pedestrian crossings, as well as lining walkways, such as the lane to the churchyard or alongside the Corn Hall. There are a few lesser quality concrete bollards in The Shambles and by the northern car parking area. Some bollards in Plowright Place have additional bars joining them together.

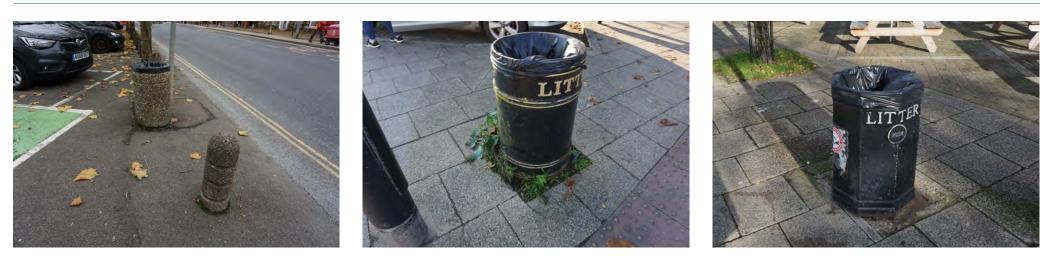
Bins

Public bins around the Market Place usually take the form of cylindrical or sometimes octagonal black tubs and with the word 'Litter' embossed in gold, which are from the 1980s scheme. One lesser quality pebbledashed concrete bin can be found close to similar bollards within the northern carpark in the Market Place.

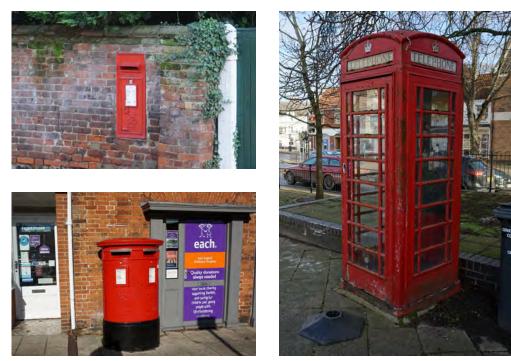
Post Boxes and Telephone Box

Post boxes in the area take the traditional form of red pillars. Either as a single or twin post box column or as a small wall mounted box. These make a particularly positive contribution to the townscape. There is a telephone box behind the Corn Hall, though this is disused and would benefit from refurbishment.

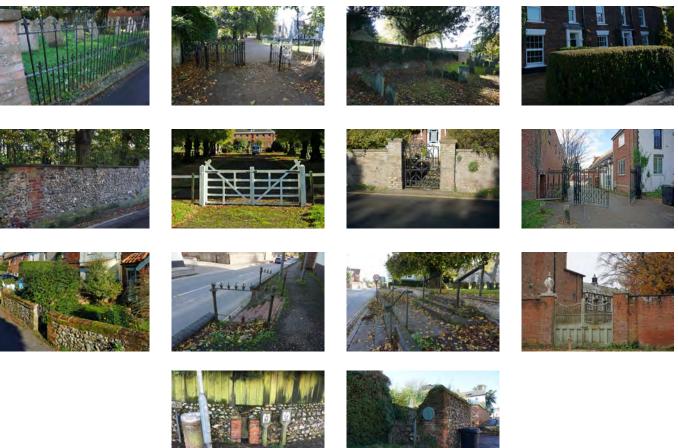
Boundary Treatments

there are two sets of historic handrails, leading from the churchyard and onto the street. One is plainer, though with scroll ends, the other with ball finials and threepointed spikes. There are also decorative metal railings to the Baptist graveyard on White Cross Road.

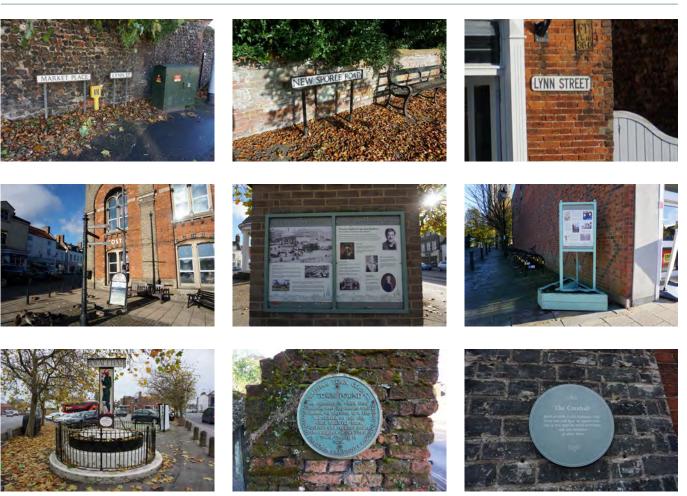
Signage

Perhaps the most important sign is the Swaffham sign at the northern end of the Market Place. This has a tall double-sided relief carving of the Swaffham pedlar in medieval travelling garb, a staff, a backpack, and his dog sitting at his feet. At the top is a cartouche with the town name surrounded by a wreath. The piece is supported with iron brackets and sits on a round base with planters for flowers and surrounded by black railings topped with golden fleurs-de-lys. It was created and unveiled in 1925, though has been replaced and the original is now in the museum. Around the town are many grey-blue plaques on notable buildings, which give details of their history. This grey-blue is used by the Town Council on woodwork

on buildings they own, as well as on signage. It can also be see in the images adjacent on the frames for interpretation signage.

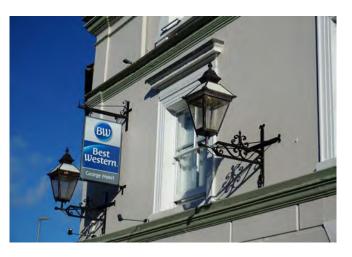
5.6.8 Lighting

Generally, streetlights are utilitarian in design which do not contribute to the character of the area, though there are some good modern examples around the Butter Cross. They include modern metal poles, sometimes painted black. There are also some more traditional wall mounted historic lamps, such as on the exterior of the George Hotel. The churchyard has lampposts topped with circular lights.

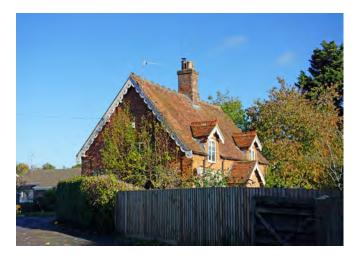
7.2.2 Keeper's Cottage

The Keeper's Cottage was built in 1832-34. Its was used as a gamekeeper's cottage for the Manor House. The Lord of the Manor at the time was Anthony Hamond. It is an attractive small house, in red brick and flint, with red clay tiles to the roof. Little flintwork remains on view in buildings in the Conservation Area, so this is unusual. It has embellishments which add to its charm, including decorative ridge tiles to the main roof and to the ridges of two dormer windows to the south elevation. There are also scalloped barge boards to the gable ends, dormers and porch. Unfortunately, the timber windows have been replaced by uPVC.

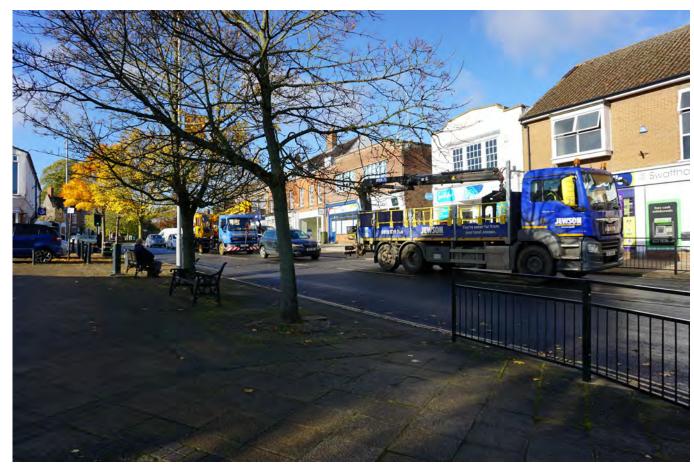
Traffic is an issue in Swaffham, particularly around the Market Place where three major roads, London Street, Station Street and Lynn Street, all converge. Roads are busy with cars and large lorries, disrupting the atmosphere of the area and frequently causing traffic jams. The traffic also causes safety issues for pedestrians, given the volume of traffic.

The convergence of the three main roads, and various other minor roads around the Market Place means there are many places where people will try to cross away from an official crossing point (although there are several), which is risky in terms of safety. This is particularly evident to the north of The Shambles where a small cut through road is located between the bus stops and car parking area, with no official crossing point between the two. There are no safe crossing points on Mangate Street, despite sets of steps leading directly from the raised pavement on the south side of the road onto the carriageway. On some of the outlying streets, such as Cley Road, the pavements can be narrow or are only located on one side of the street.

Heavy traffic around the Market Place
